**DARPA R&D Status Report**

**Contractor:** General Electric Corporate Research and Development

**Short Title of Work:** Non-toxic, Self Cleaning Silicone Foul Release Coatings

**Reporting Period:** January through March 2000

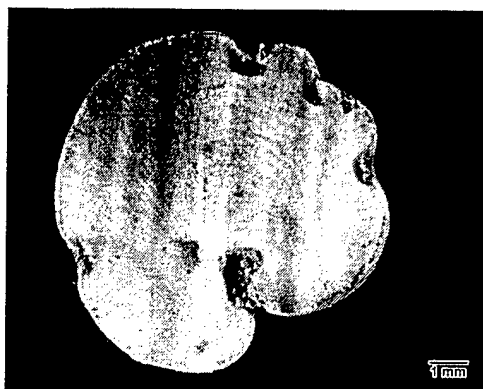
Figure 1. Basal plate of *Balanus improvisus* removed from non-silicone surface

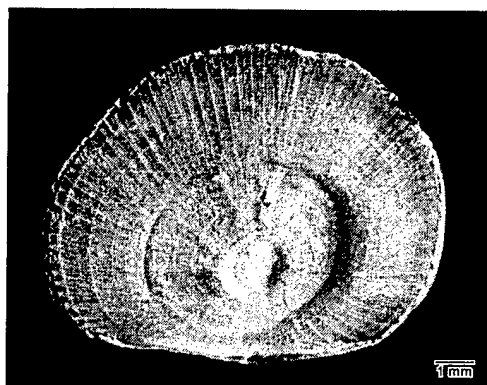
Figure 2. Basal plate of *Balanus improvisus* removed from GE topcoat

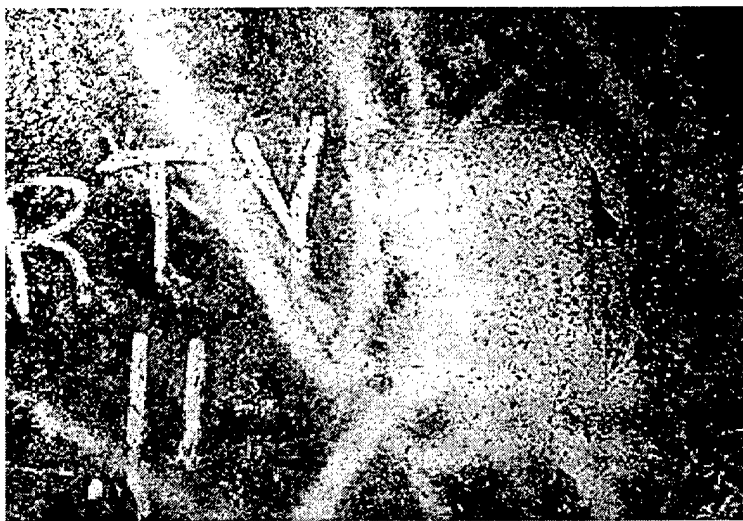
The Navy Duplex systems with GE RTV11 and Exsil 2200 topcoats were applied to portions of the cooling water tunnels in March 1995 during the ESTCP project. At the time of this inspection (March 2000), the coatings were still intact and performing well against zebra mussels. There was minimal amount of coating damage or delamination (approximately 2-3%). The damage and delamination appeared to be a result of biological activity. The slimes and sediment on the coating surface could be removed with light pressure or water spray (Figures 1 and 2). Both coatings had low concentrations of zebra mussels (only attached at surface cavities) which could be easily removed (Figure 3). The results of this inspection are similar to the results seen for the March 1996 inspection. Thus, these coatings are still performing well after 5 years of immersion.

Figure 2. RTV11 covered with slime and sediment which could be easily cleaned with water spray.

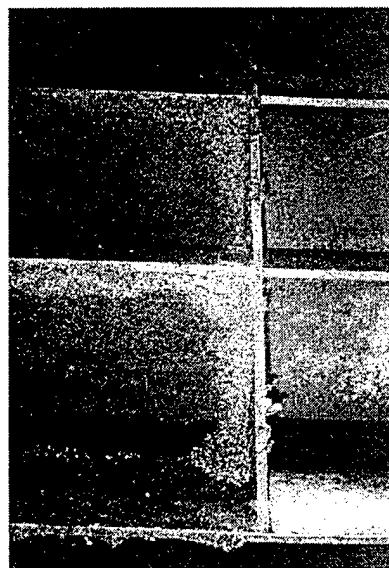
Figure 3. Photo of the steel baffles (left side not coated and the right side coated with RTV11).
